**DEPARTMENT OF TRANSPORTATION**

Contract #: 04-0120F4Cty: SF/ALA Rte: 80 PM: 13.2/13.9File #: 70.28**WELDING INSPECTION REPORT****Resident Engineer:**Pursell, Gary**Address:** 333 Burma Road**City:** Oakland, CA 94607**Report No:** WIR-005726**Date Inspected:** 05-Mar-2009**Project Name:** SAS Superstructure**Prime Contractor:** American Bridge/Fluor Enterprises, a JV**Contractor:** Japan Steel Works**OSM Arrival Time:** 830**OSM Departure Time:** 1630**Location:** Muroran, Japan**CWI Name:** Chung Fu Kuan**CWI Present:** Yes No**Inspected CWI report:** Yes No N/A**Rod Oven in Use:** Yes No N/A**Electrode to specification:** Yes No N/A**Weld Procedures Followed:** Yes No N/A**Qualified Welders:** Yes No N/A**Verified Joint Fit-up:** Yes No N/A**Approved Drawings:** Yes No N/A**Approved WPS:** Yes No N/A**Delayed / Cancelled:** Yes No N/A**Bridge No:** 34-0006**Component:** Tower, Jacking, and Deviation Saddles**Summary of Items Observed:**

Grinding and Welding Operation: West Deviation Saddle Segment W2W1

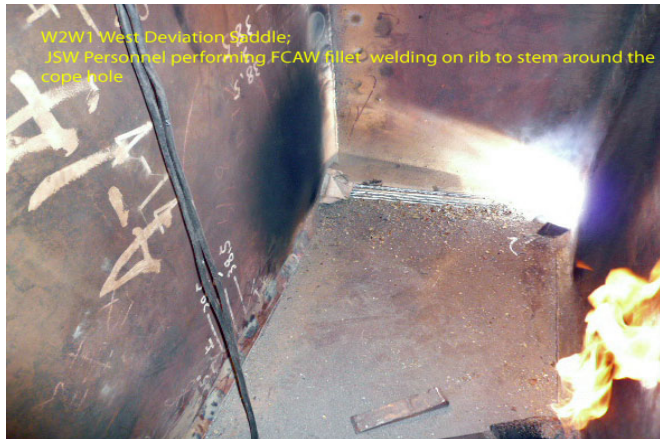
The QA Inspector observed the following work in process: grinding operation of the cope holes on the Rib plate to Stem plate at locations 4-12 and 4-16. The QA Inspector also observed the fillet welding operation around the cope holes on the Rib plate to Stem plate at locations 4-8 and 4-10. The QA Inspector observed QC Inspector Mr. Chung Fu Kuan verify prior to the start of welding that the preheat temperature of 160 degrees Celsius was maintained and the welding parameters of JSW welding personnel Mr. M. Kashiwada (08-2008) and Mr. M. Kubota (74-3666) were in compliance with WPS SJ-3011-14 per the FCAW process in the (2F) horizontal position.
